ROSS POND DAM

NDI I.D. PA-0265

PHASE I INSPECTION REPORT
NATIONAL DAM INSPECTION PROGRAM

ROSS POND DAM
NDI I.D. PA-0265
DER I.D. 058-142
MARCH 23, 1981

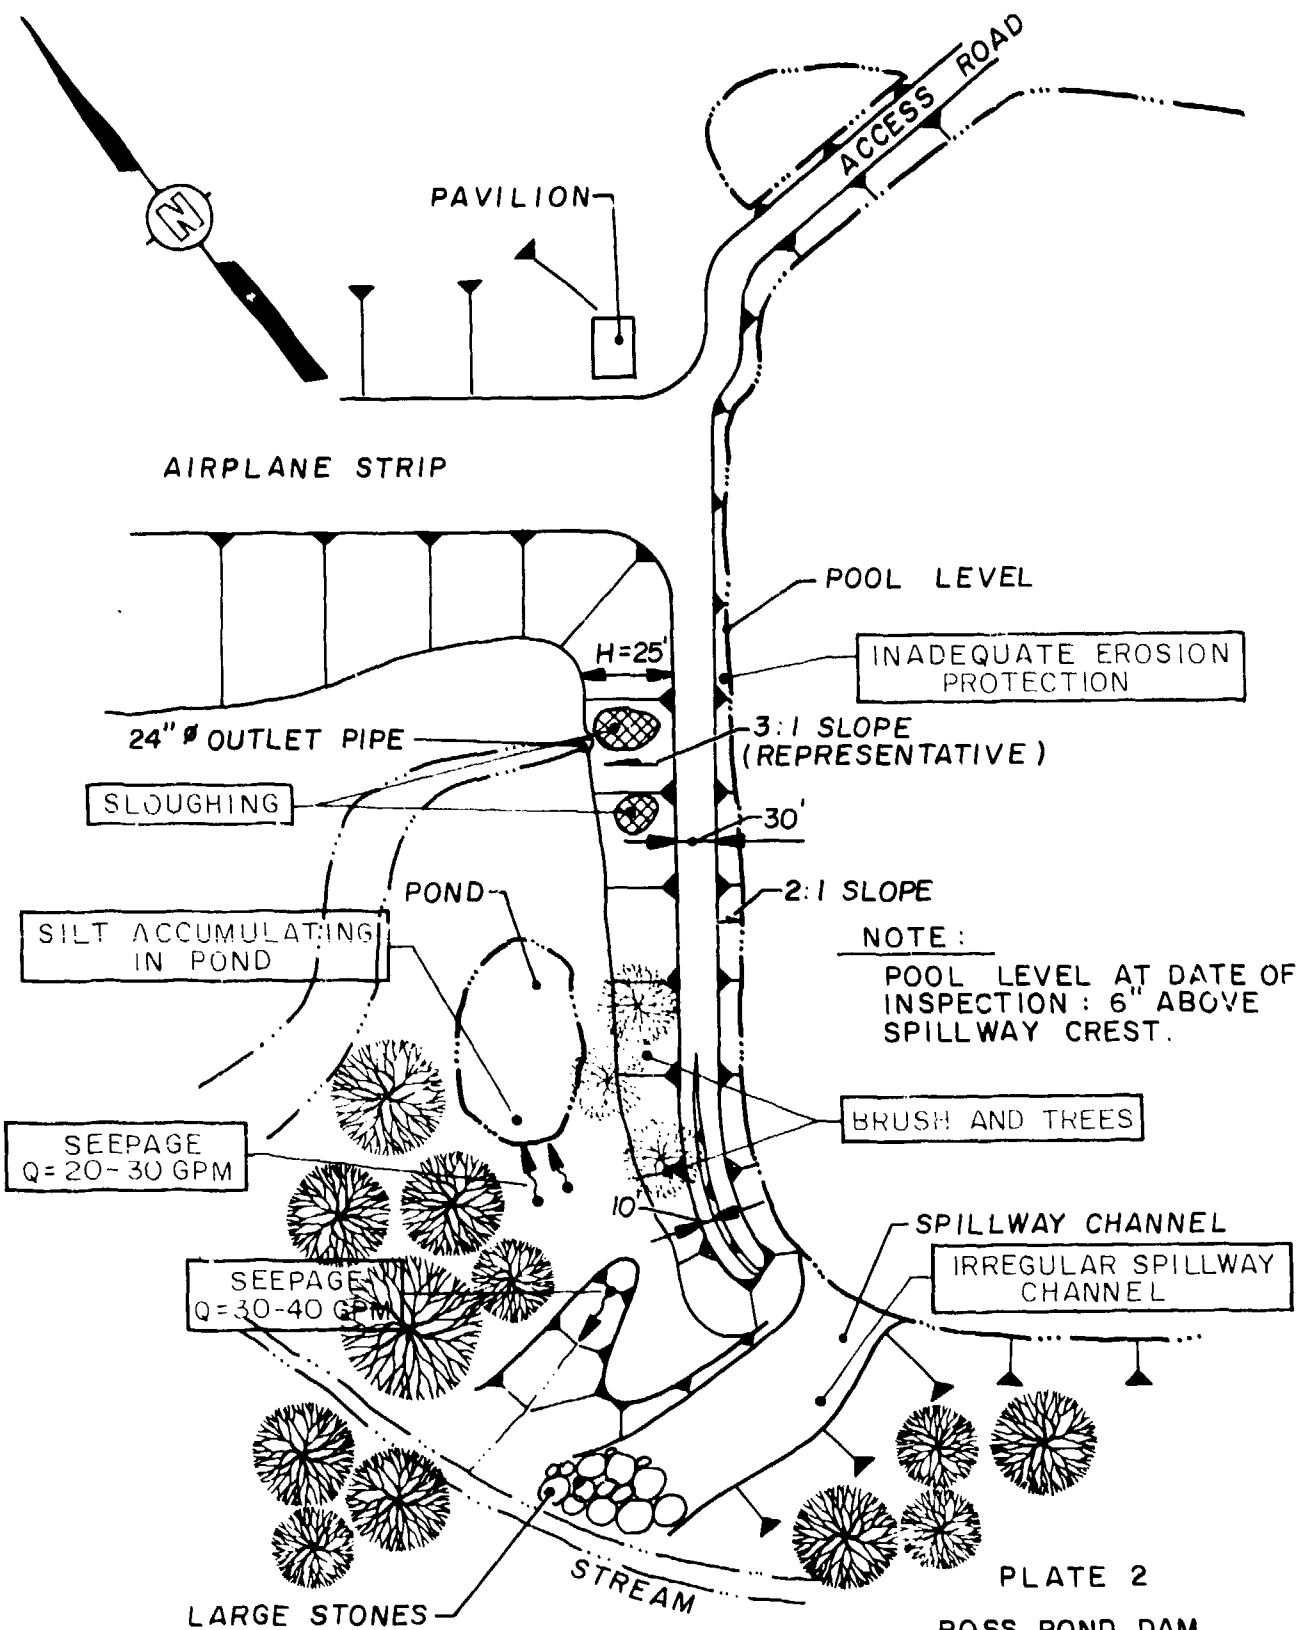
ROSS POND DAM
 GENERAL PLAN
 FIELD INSPECTION NOTES
 FIELD INSPECTION DATE: MAR. 23, 1981

The specific observations are illustrated in Plate 2.

In general, the dam is considered to be in fair condition. The two most notable conditions found at the dam were the presence of a surficial slough on the downstream face at the middle section of the embankment and indications of water seepage through the left half to one-third of the embankment.
